DX200

MAINTENANCE MANUAL

(Volume 1)

MANUAL NO. RE-CHO-A113

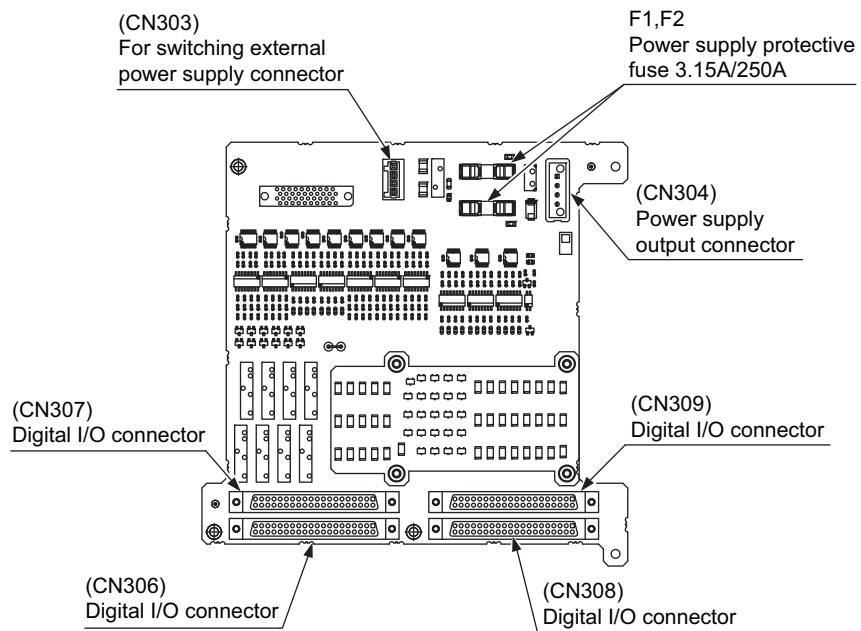
Fig. 5-6: Universal I/O circuit board (JANCD-YIO21-E)

1. Remove the back circuit board from the upper back of the DX200.
2. Remove the cover over the universal I/O circuit board.
3. Remove the all cables connected to the universal I/O circuit board.
4. Loosen the screws (six places) fixing to the universal I/O circuit board.
5. Remove the universal I/O circuit board from the machine safety I/O logic circuit board (JANCD-YSF22□-E).
6. Insert the new universal I/O circuit board connector (CNA) into the machine safety I/O logic circuit board (JANCD-YSF22□-E) connector (CNA).
7. Tighten the six fixing screws of the universal I/O circuit board firmly.
8. Reinstall the all disconnected cables from the universal I/O circuit board.
9. Replace the cover on the universal I/O circuit board.
10. Replace the back circuit board on the upper back of the DX200.

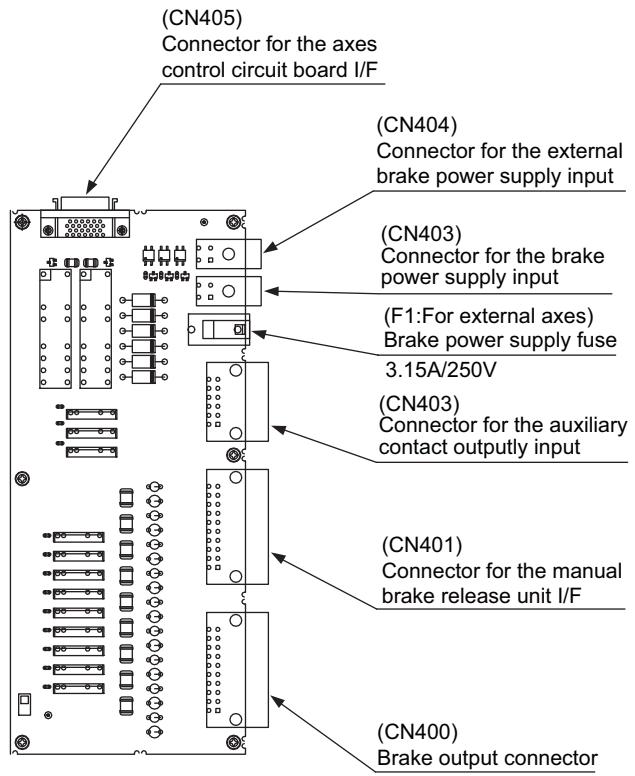
Fig. 5-8: Brake Circuit Board (JANCD-YBK21-3E)

1. Turn OFF the breaker and the primary power supply and wait at least 5 minutes before replacement. Do not touch any terminals during this period.
2. Verify that the converter (SRDA-COA30A21B-E) charge lamp (red LED) is unlit.

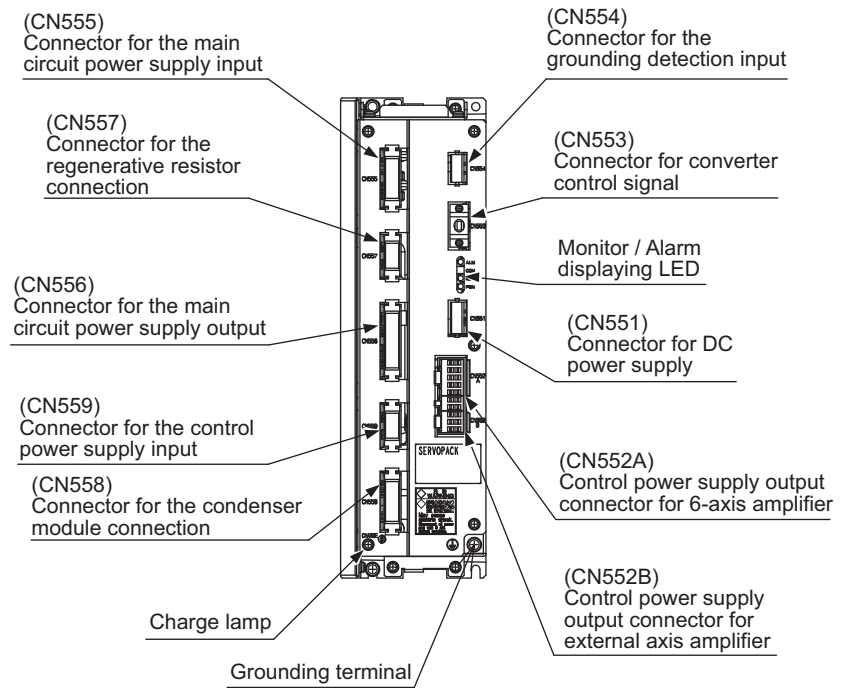
Fig. 5-14: Converter

- (10) Capacitor module connector (CN558)
4. Remove the grounding wire connected to the converter.
5. Remove the two upper screws fixing the converter. Loosen the lower screws fixing the converter.

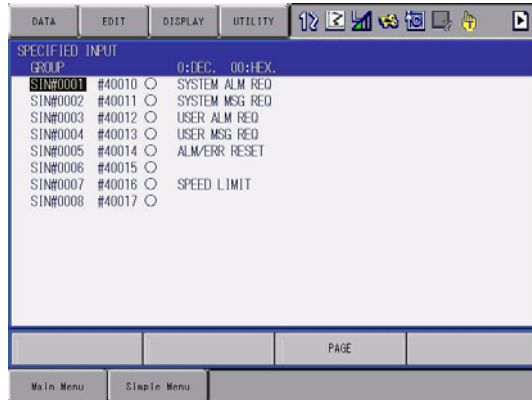
7.3.3.1 Specific Input Window

1. Select {IN/OUT} under the main menu.
2. Select {SPECIFIC INPUT}.
 - The SPECIFIED INPUT window appears.

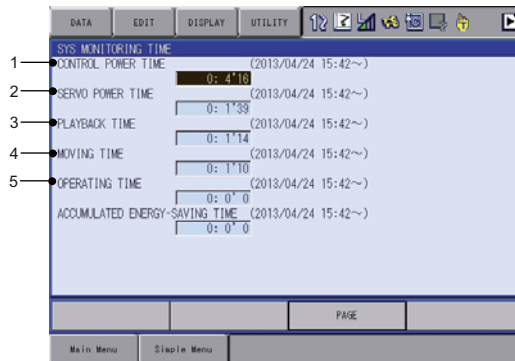
7.4.1 System Monitoring Time Display Window

The status of system operation, e.g. power ON time, can be checked.

1. Select {SYSTEM INFO}.
2. Select {MONITORING TIME}.
 - The SYS MONITORING TIME window appears.

1, CONTROL POWER TIME

Displays the cumulative time that the main power supply has been ON.

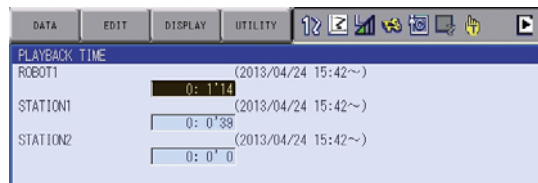
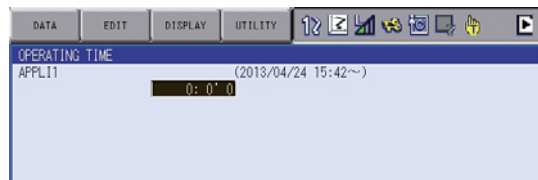
7.4.2 Individual Window of the System Monitoring Time Display

If the [PAGE] key is pressed, or "PAGE" is selected to display the selection window for the system monitoring time display, the servo power time, playback time, moving time, and each-application operating time by each control group are individually displayed.

The total time of each control group here is not always the same as the time in the SYS MONITORING TIME window because these windows show time as seen from the individual control group.

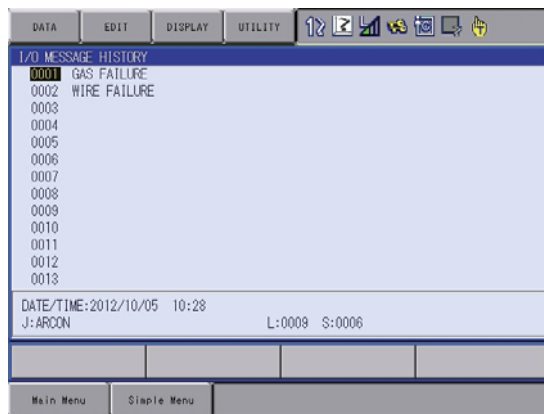
The I/O MESSAGE HISTORY window shows the date and time, job name, line number, and step number of the I/O message that appeared on the window.

1. Select {SYSTEM INFO} under the main menu.
2. Select {I/O MSG HISTORY}
 - The I/O MESSAGE HISTORY window appears.

Press [SELECT], and numeric values can now be entered. Input the history number, and press [ENTER]. The search for the input history number begins, and the I/O message that appeared on the window is displayed.

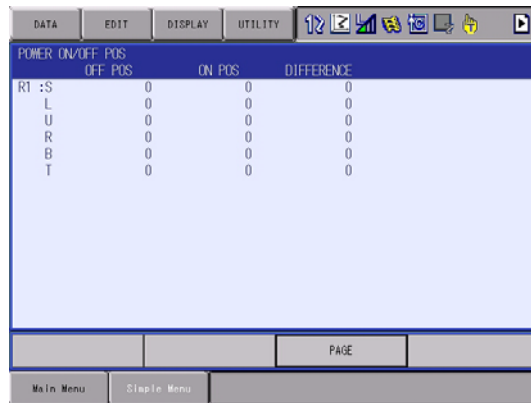
The Power ON/OFF position window shows the position of the manipulator when power was turned OFF the last time, the current position of the manipulator when power was later turned ON, and the amount of difference between the two positions. When alarm 4107, "OUT OF RANGE (ABSOLUTE DATA)" occurs, the error value of the faulty axes can be verified in this window.

1. Select {ROBOT} under the main menu.
2. Select {POWER ON/OFF POS}.
 - The POWER ON/OFF POSITION window appears.

OFF POS	ON POS	DIFFERENCE
RI :S	0	0	0
L	0	0	0
U	0	0	0
R	0	0	0
B	0	0	0
T	0	0	0

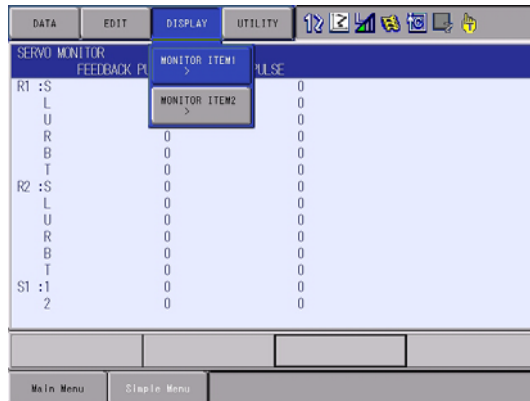
4. Select {DISPLAY} under the menu.
 - The pull-down menu appears.
 - MONITOR ITEM 1 is the data on the left, and MONITOR ITEM 2 is the data on the right

SERVO MONITOR			
	FEEDBACK PULSE	ERROR PULSE	
R1 :S	0	0	
L	0	0	
U	0	0	
R	0	0	
B	0	0	
T	0	0	
R2 :S	0	0	
L	0	0	
U	0	0	
R	0	0	
B	0	0	
T	0	0	
S1 :1	0	0	
2	0	0

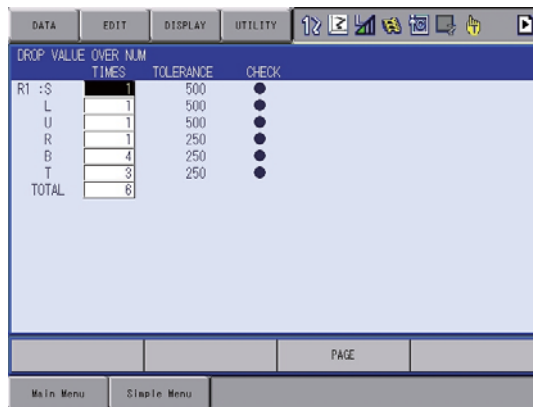
1. Select {ROBOT} in the main menu.
2. Select {DROP VALUE}.
 - The DROP VALUE OVER NUM window appears.

TIMES	TOLERANCE	CHECK
R1 :S	1	500	●
L	1	500	●
U	1	500	●
R	1	250	●
B	4	250	●
T	3	250	●
TOTAL	8

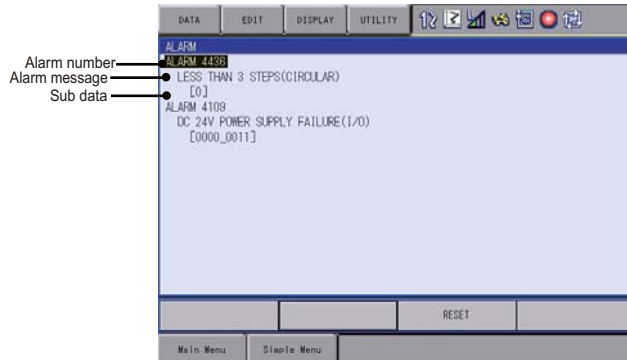
If an alarm occurs during operation, the manipulator stops immediately and the ALARM window appears on the programming pendant indicating that the machine was stopped by an alarm.

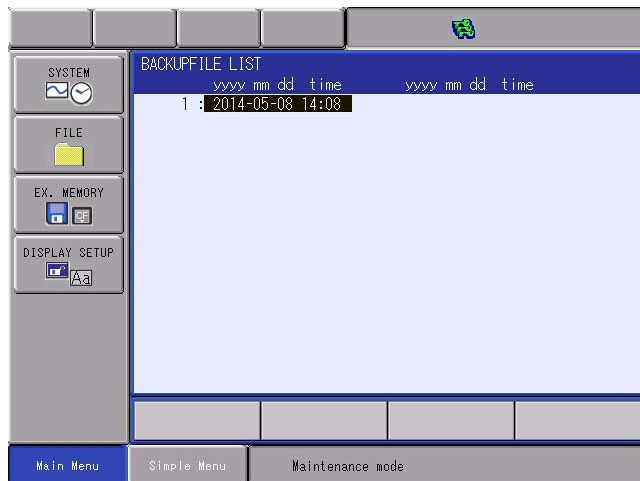
1. Turn ON the DX200 while pressing down the [MAIN MENU].
 - The maintenance mode starts.
2. Set the security mode to the one time manage mode.
3. Select {EX. MEMORY} under the main menu.
 - The sub menu appears.
4. Select {SYSTEM RESTORATION}.
 - The backup file list window appears.
